# Your Inspection Report

EXAMPLE REPORT - The findings in this report were generated as examples

RE: Report No.  
XX Street  
City, CO  
Zip

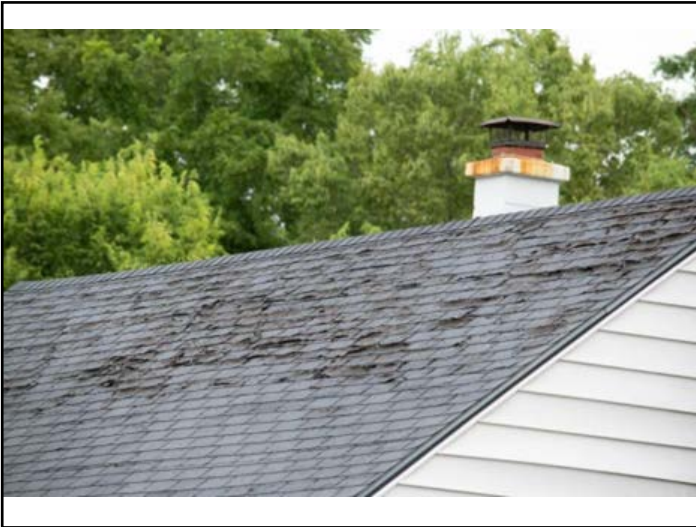
**Narrative:** The roofing material is asphalt shingles. Several shingles are missing, cracked, or curling, indicating advanced wear. There is visible granule loss across large sections, potentially reducing the roof's ability to protect against weather. Flashing around vents, chimneys, and other roof penetrations is either damaged or improperly sealed, increasing the risk of leaks. Additionally, the ridge caps show signs of damage. Based on these observations, the roof may no longer provide adequate protection, and it is recommended that a qualified roofing professional inspect the roof prior to the sale of the home. The method of inspection was drone.

Comment: Image of damaged roofing material.

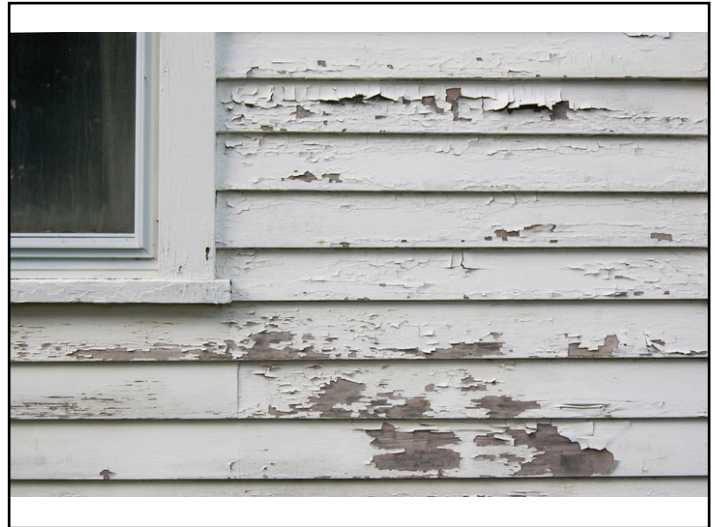
**Narrative:** Several sections of the siding are damaged, with visible cracks and warping. These areas may allow moisture intrusion. Additionally, the foundation exhibits cracks, some of which are significant in size. These cracks could indicate potential structural issues or settling concerns, and further evaluation by a structural engineer is recommended. It is recommended that a qualified building professional conduct an inspection in order to determine the extent of the damage observed.

Comment: Damaged siding

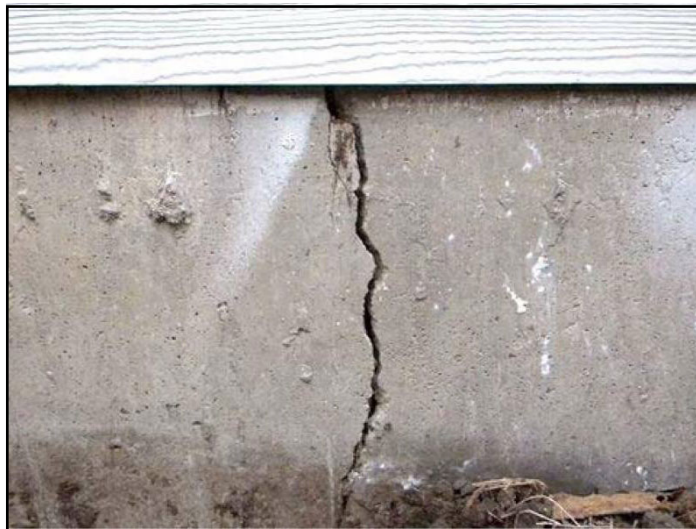
**Narrative:** Several foundation cracks were observed, some of which are significant in width and depth. While small, hairline cracks may be common in concrete foundations, the size and extent of these cracks suggest a possible concern with settlement or shifting. It is recommended that a structural engineer further assess the foundation to determine the cause and scope of the issue.

Comment: Foundation crack indicative of settling on the north side of the house

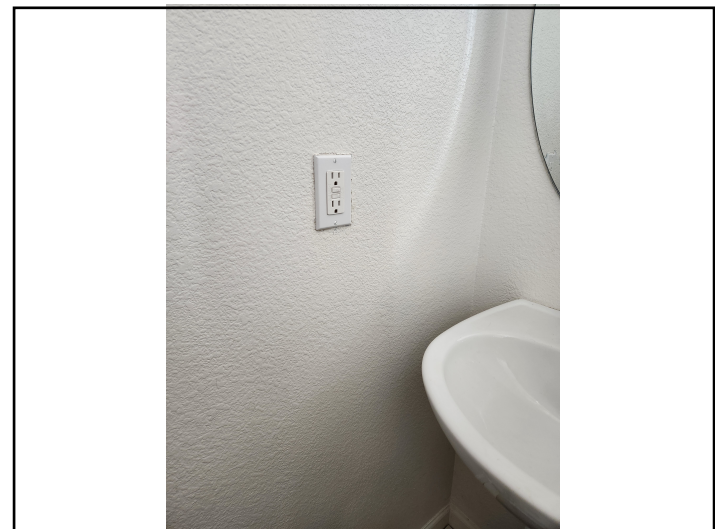
**Narrative:** During the inspection, the Ground Fault Circuit Interrupter (GFCI) outlet in the downstairs bathroom was found to be non-functional. This outlets did not respond to the test/reset function and is not providing the required protection against electrical shock in a potentially wet area. Non-functional GFCIs present a safety hazard and should be replaced or repaired immediately to restore proper function and ensure the safety of the electrical system. A licensed electrician is recommended to address this issue.

Comment: Non-functioning GFCI outlet in downstairs bathroom

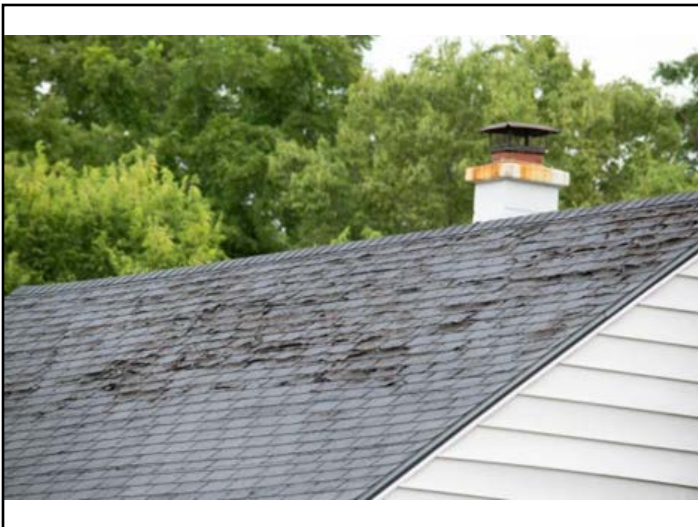
**Items to cover in narrative:** Several shingles are missing, cracked, or curling, indicating advanced wear. There is visible granule loss across large sections, potentially reducing the roof's ability to protect against weather. Flashing around all vents, chimneys, and other roof penetrations is either damaged or improperly sealed, increasing the risk of leaks. Additionally, the ridge caps show signs of damage and several sections were removed entirely. Based on these observations, the roof may no longer provide adequate protection, and it is recommended that a qualified roofing professional inspect the roof prior to the sale of the home. The method of inspection was drone.

Comment: Heavily damaged section of roof

- 1. Condition:** Due to the multiple issues found during the visual inspection, it is recommended that a roofing professional be consulted to determine the true extent of the damage/condition of the roof prior to purchasing.

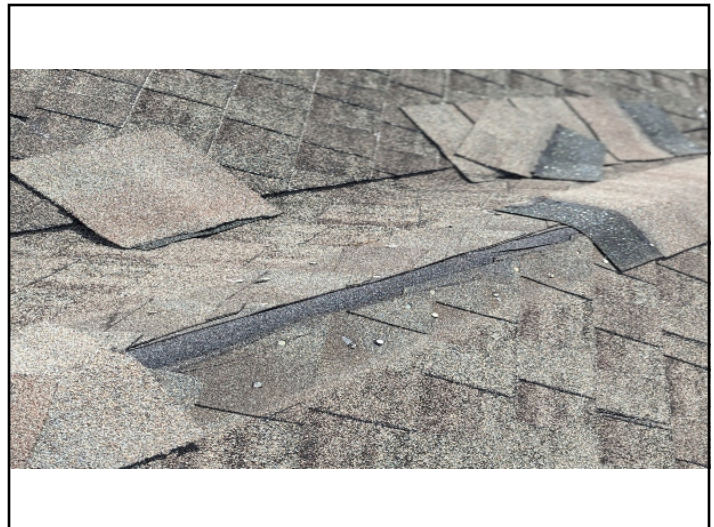
Comment: Damaged ridge cap

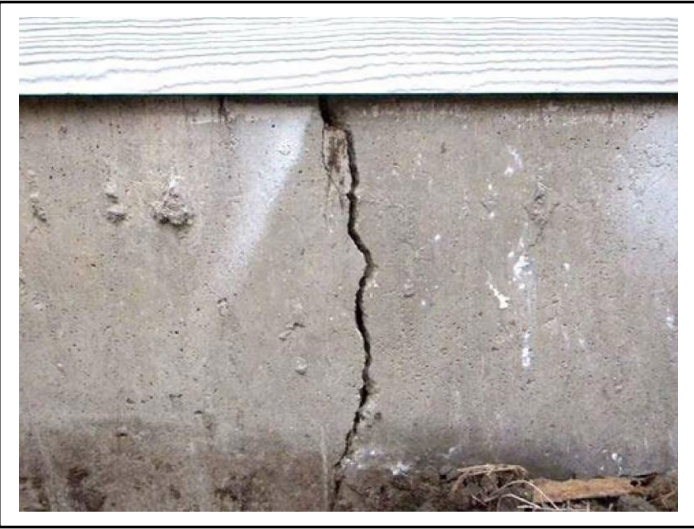
The exterior inspection revealed damage to the siding and a cracked foundation, both of which need attention. Several areas of the siding are cracked and warped, creating potential points of moisture intrusion. Additionally, the foundation shows significant cracking, which could indicate structural issues or settlement. It is recommended to have a structural engineer evaluate the foundation for further assessment.

Comment: Observed foundation crack

- RECOMMENDATIONS \ General**
- 1. Condition:** Foundation cracks could indicate significant structural issues and it is recommended that a structural engineer evaluate the observed cracks further prior to purchasing the home.
  - 2. Condition:** Damaged siding, if left in current condition, could allow moisture to enter the interior structure of the home. It is recommended that a licensed builder evaluate the damage and perform any necessary repairs.

- Condition:** It is highly recommended that a structural engineer inspect the noted foundation crack as outlined here and in the Exterior section.

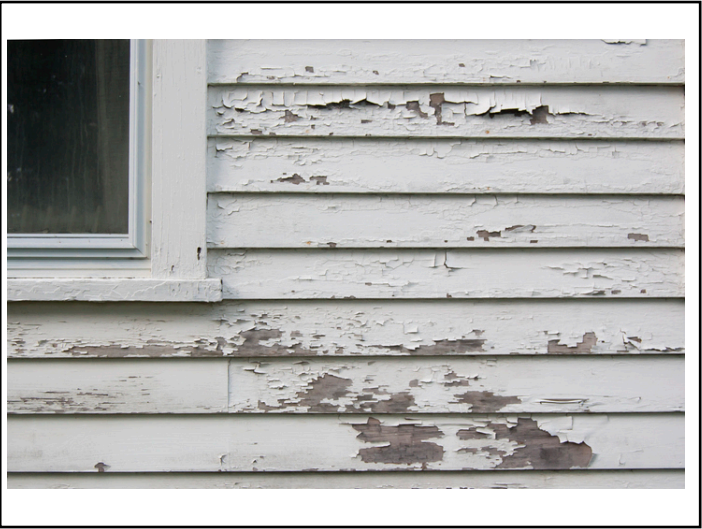
Comment: Siding damage

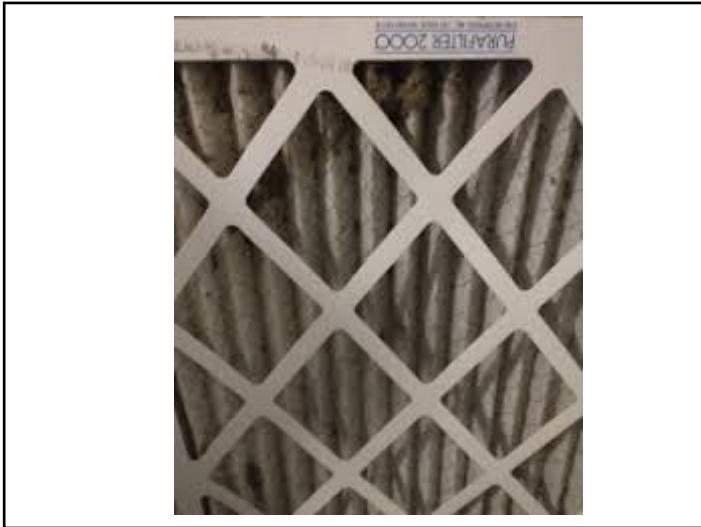
The vents, supply, and return systems all appear in good condition. The thermostat is located in the downstairs living room. The only thing of note is that the furnace filter was found to be in need of replacement, as it showed signs of dirt and debris buildup. Regular filter changes are recommended to ensure optimal efficiency and air quality. The gas meter and shutoff is located on the left side of the house.

Comment: Dirty air filter

**1. Condition:** Replace the old air filter. A dirty air filter can negatively affect the system in several ways. When the filter becomes clogged with dirt and debris, it restricts airflow, forcing the furnace to work harder to push air through the ducts. This reduces efficiency and increases energy consumption. The strain caused by reduced airflow and overheating can accelerate wear and tear on components like the blower motor, shortening the system's lifespan. Regularly changing or cleaning the filter is essential to maintain the furnace's performance, efficiency, and safety.

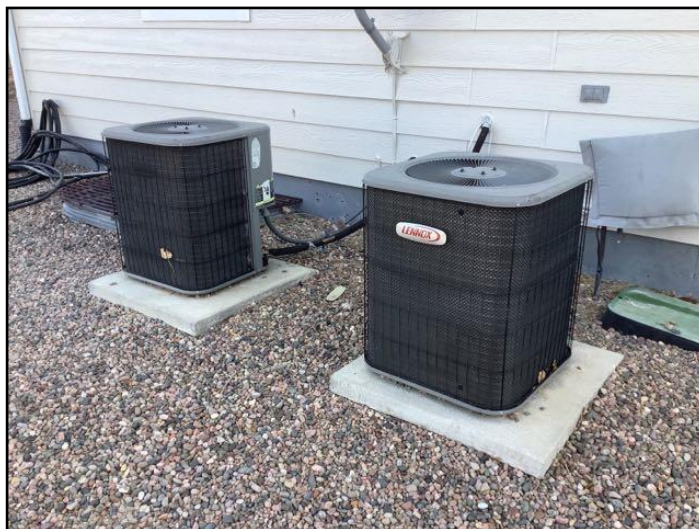
The home is equipped with two air conditioning units: one servicing the basement and ground floor, and the other servicing the upstairs. Both units are approximately 15 years old, which means they may be nearing the end of their typical service life. While no immediate defects were observed, it is recommended to monitor the performance of the units closely and plan for potential replacement in the near future.

Comment: Dual A/C units

1. **Condition:** Since the A/C was not tested during this home inspection due to the fact that this inspection was conducted in the winter, it is recommended that the units be serviced/tested when appropriate by an HVAC technician.
